Subject: Smoky Canyon Mine Remedial Investigation/Feasibility Study  
Dinwoody Material Source Investigation Report

**To:** Jeff Hamilton, Environmental Engineering Manager; Grant Williams, Senior Mine Engineer  
**From:** Katie Wilkes, Geologist  
**Cc:** Neil Musilek, Engineering Manager; Casey McCaslin, Survey  
**Date:** November 27, 2018  
**Re:** **Dinwoody Material Source Investigation Report**

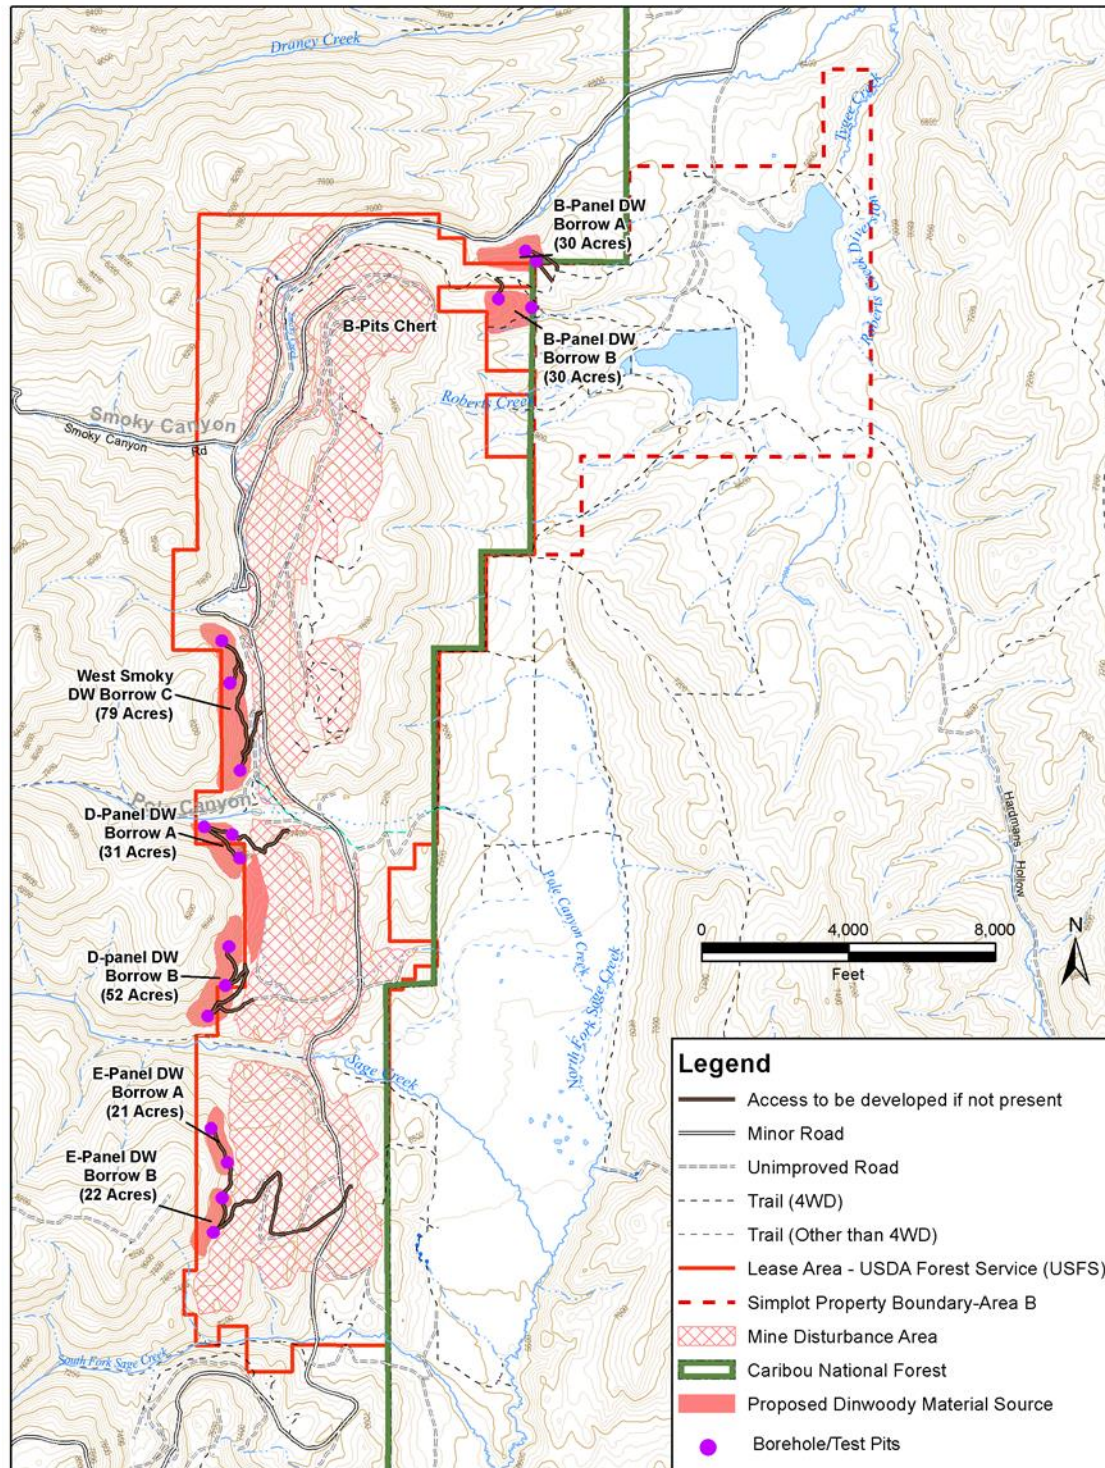
**Figure1 – RI Dinwoody Borrow Test Excavation Sites**

The objective of this investigation is to provide site-specific information needed for the detailed analysis of remedial alternatives in the FS by locating, delineating, and estimating available volumes of Dinwoody material for potential future use. The potential borrow sources investigated for further evaluations included B-Panel A & B, West Smoky C, D-Panel A & B, and E-Panel A & B. **Figure 1** shows the areas included in this investigation.

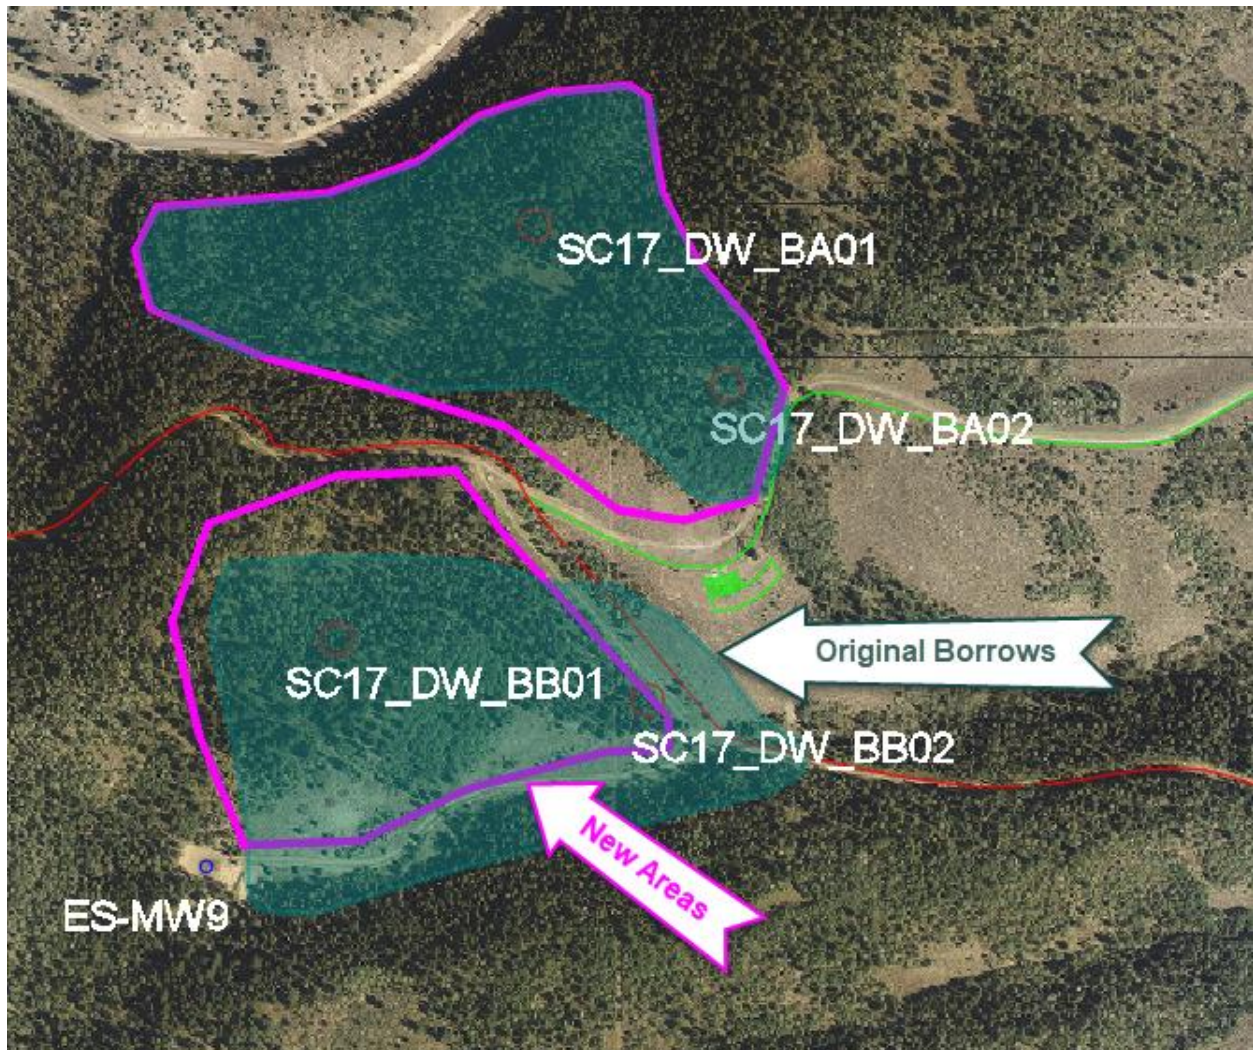
**Figure 2 – B-Panel Borrow**

Documentation for each excavation site and any other field observations are in the trench logs attachment. B-Panel borrow contained excellent clay rich material overall. All excavations in this area were extended to the maximum reach of the equipment. Site DW\_BB02 had some less desirable gravelly zones near the surface and has been adjusted to the edge of the borrow area. **Figure 2** indicates the areas of the original B-Panel borrow designs and the new adaptations following examinations from this field program. Selected images for each site are included in this report, additional photo documentation is available within the attachments.

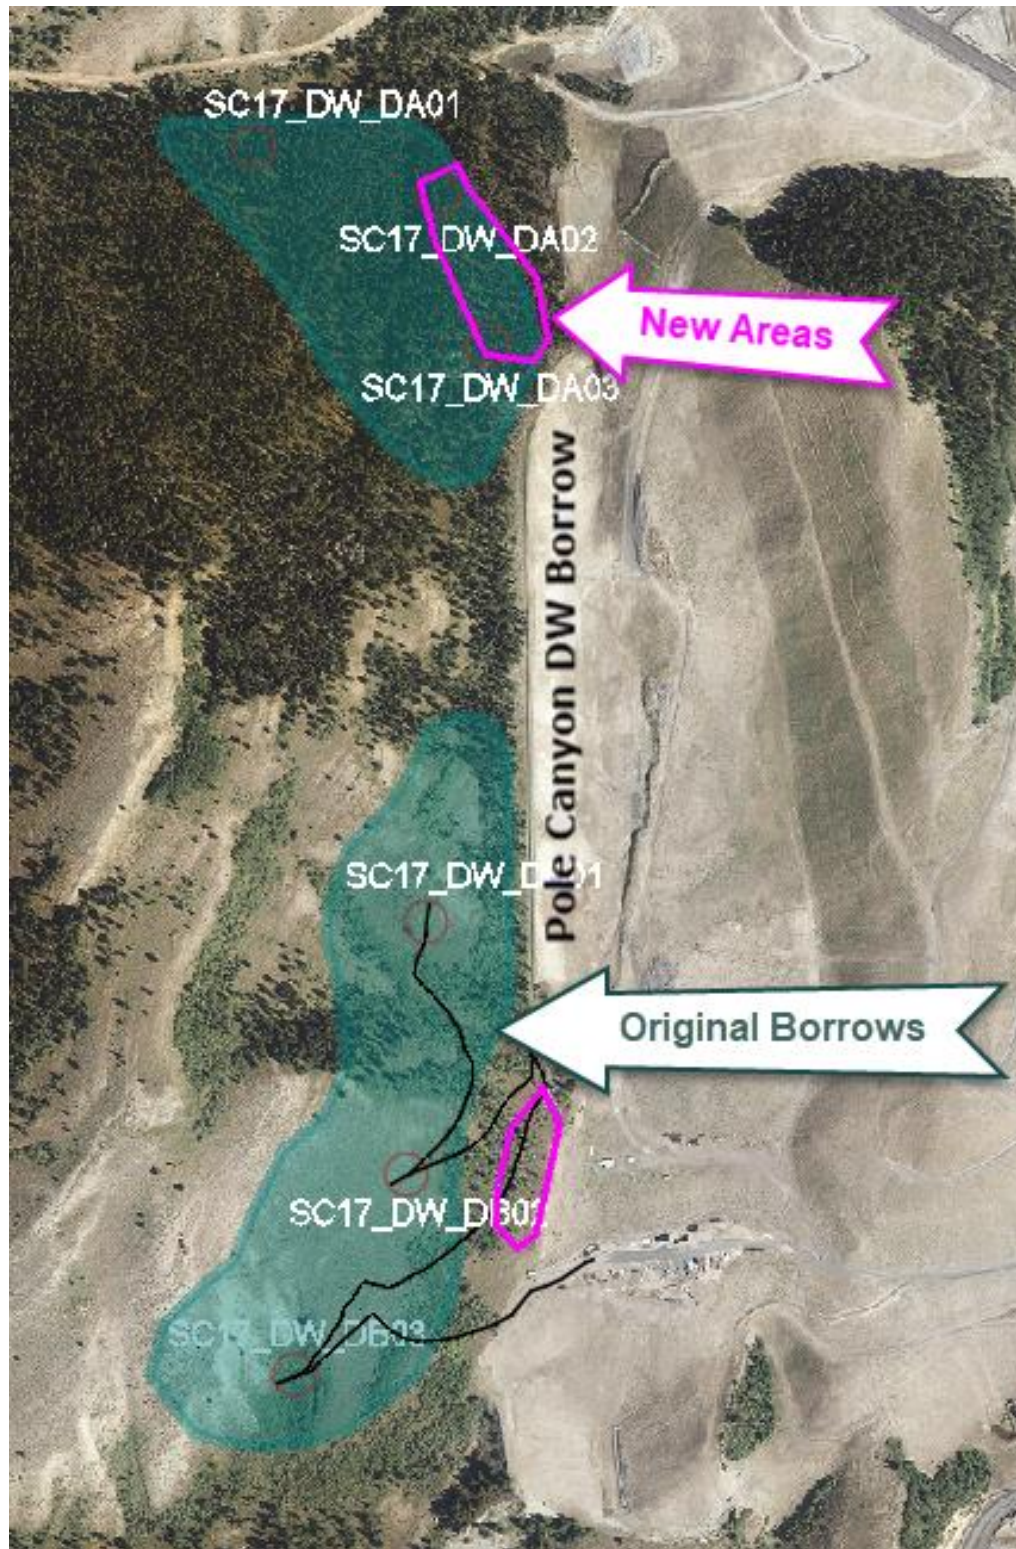
**Figure 3 – D-Panel Borrow**

All sites were terminated at refusal of digging and ripper teeth were broken on the rock at sites DA01 and DA03. Although none of the excavation sites indicated good quality Dinwoody cover material, road cuts were considered in evaluation of the site as a whole. Additional field notes for the D-Panel borrow areas and excavation sites are in the trench logs attachment. A general observation in the steep D and E panel areas is that there is more cliff forming rock with elevation up the slope. **Figure 3** indicates the areas of the original D-Borrow designs and the adaptations following examination from this field program. Selected images for each site are included in this report and additional photo documentation is available within the attachments.

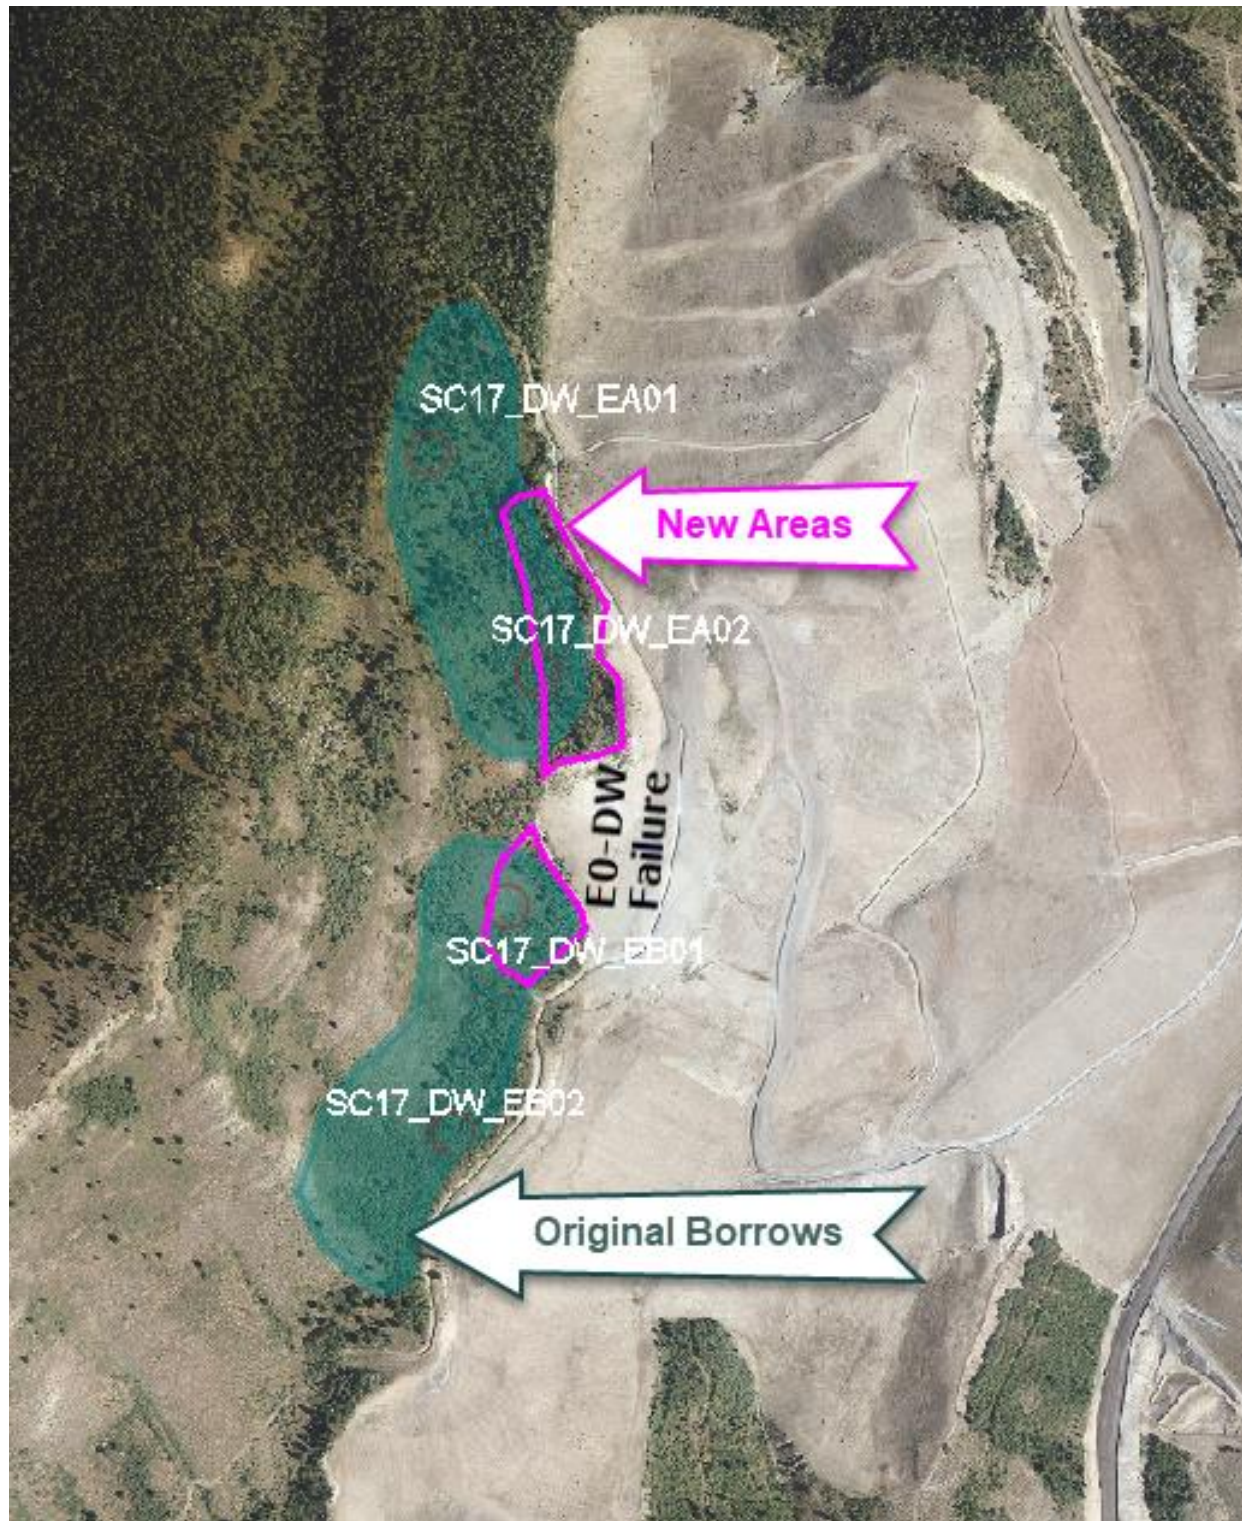
Figure 4– E-Panel Borrow

**Figure 4** indicates the areas of the original E-Borrow designs and the adaptations following examinations from this field program. Selected images for each site are included in this report with additional photo documentation available within the attachments.

Volumes in this area were updated within a much smaller areas. Calculations within this area assumed 3 feet of topsoil and 15 feet total depth for excavating material below topography. Most of this material would not be suitable for cover material.
